# Watts Bar Unit 2

Nick Welch

June 2018

# Watts Bar Unit 2 Overview

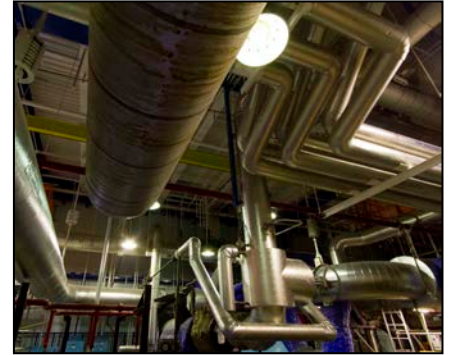
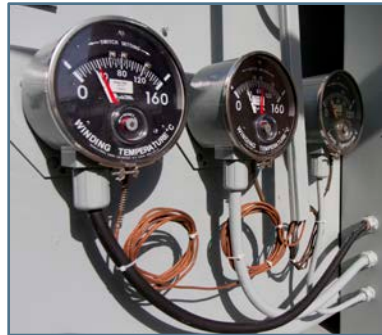
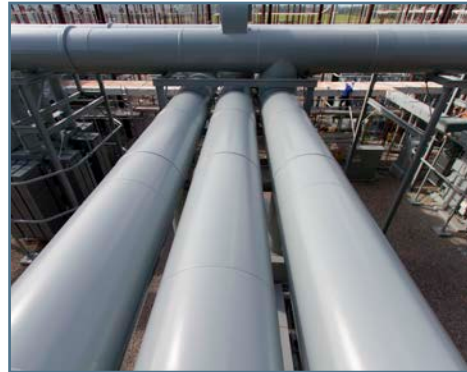
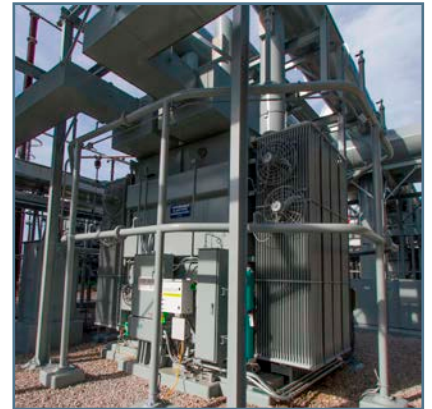
- Piping replaced to address flow accelerated corrosion
- Alloy 600 addressed
- Switchyard upgraded, transformers refurbished and tested

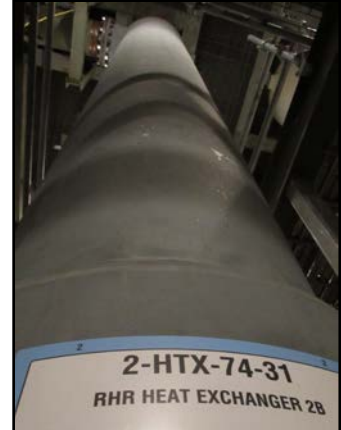
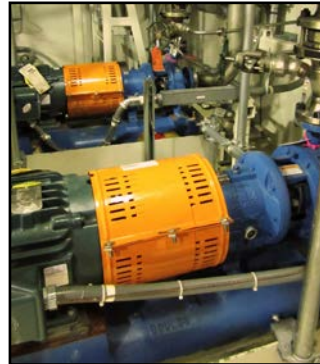
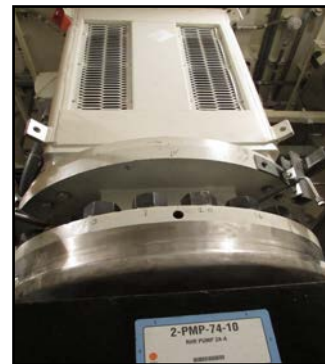
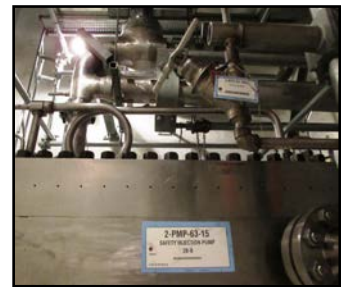
- Auxiliary and Reactor Building
  - New reactor coolant pumps
  - Pump motors rebuilt, including reactor coolant pump motors
  - Control panels reworked
  - ~100 transmitters replaced

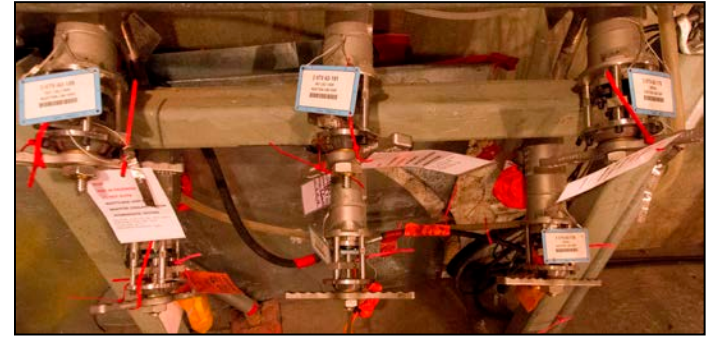
- Auxiliary and Reactor Building
  - Valves
    - 470 valves replaced
    - Internals disassembled, inspected, and cleaned, lubricants changed
    - Actuator diaphragms replaced, positioners replaced/rebuilt, and limit switches replaced
    - New Safety Injection System vent valves installed

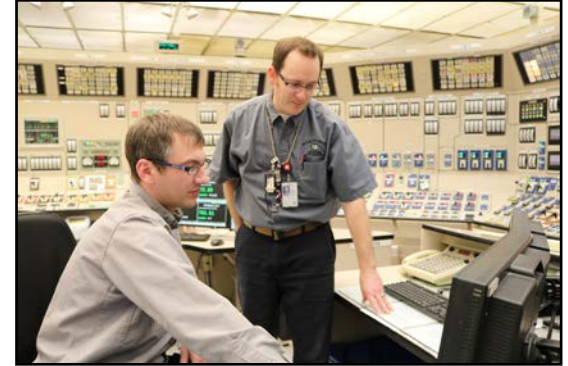
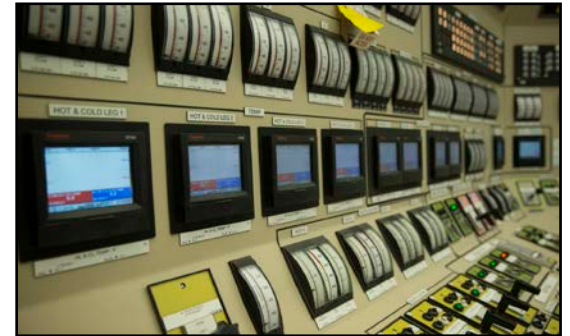
- Main Control Room
  - Instruments and controls made to match those on Unit 1
  - New equipment installed
    - Rod Position Indication System
    - In-core Instrument System
    - Reactor Vessel Level Indication System
    - Integrated Computer System
    - Annunciator System
    - Panel indicators, recorders, and controllers
  - Switches refurbished, tested, and reinstalled
  - ~80,000 feet of new wiring installed

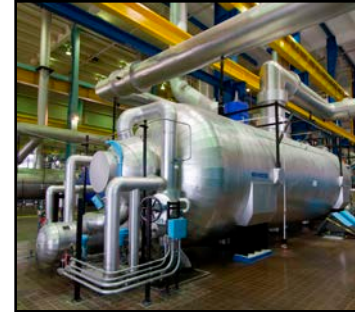
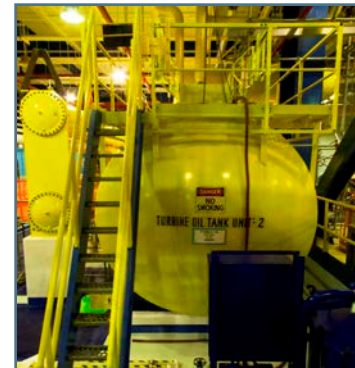
- Turbine Building
  - Moisture separator reheaters replaced
  - Main turbine oil tank cleaned and coated inside and out and high velocity flush of oil system performed
  - Piping susceptible to flow accelerated corrosion replaced
  - Main feedwater pumps upgraded
    - Turbine rotors were replaced by Siemens
    - High-pressure and low-pressure inlet valves rebuilt
    - Control panel reworked with new indicators, switches, and lights
  - Stand-by main feedwater pump
    - Pump and motor rebuilt
    - Control panel reworked with new indicators, switches, and lights

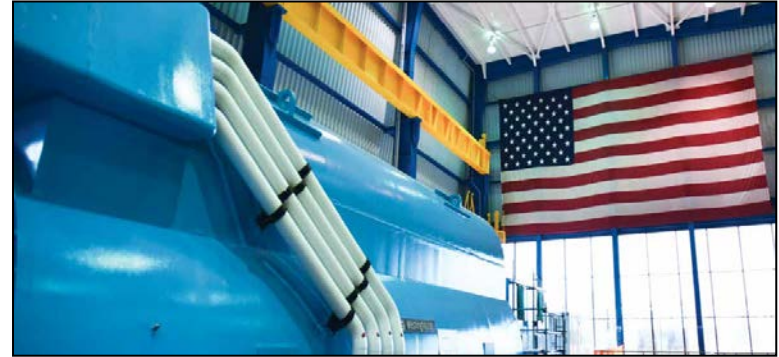
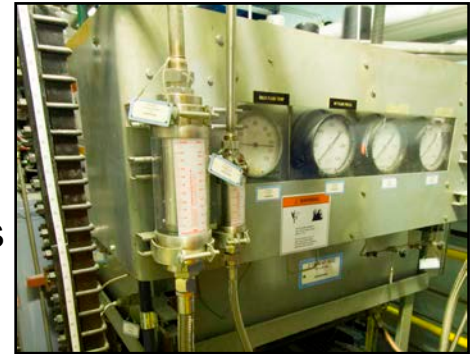
- Turbine Building
  - Turbine upgraded
  - Main condenser retubed to remove copper, installed SEA-CURE stainless steel tubing
  - Electric hydraulic control system improved
    - Pump motor rebuilt
    - New constant pressure pump installed
    - Tank cleaned and inspected
    - Control panel refurbished with new switches and indicators
  - ~215 piping inspections
  - Main steam and feedwater piping internal inspections

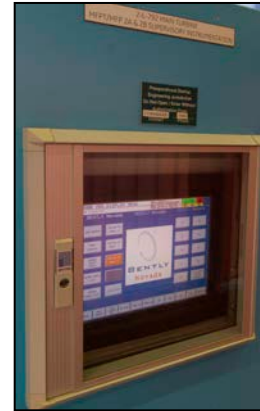
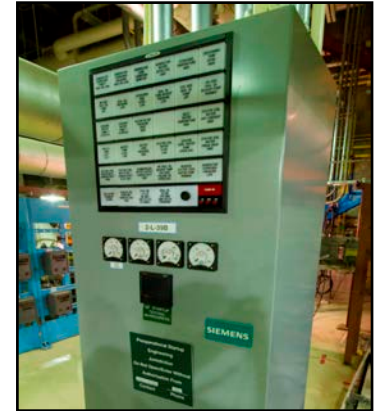
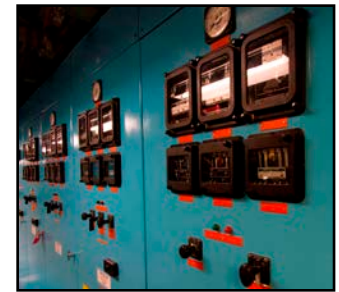
- Digital upgrades made including:
  - New digital, dual-channel voltage regulator for main generator and exciter
  - New digital supervisory instrumentation for main turbine
  - New local instrument control panel for generator stator cooling hydrogen
- Electrical systems connecting main control room and plant equipment upgraded and refurbished
- Controls for non-nuclear equipment upgraded and refurbished to better ensure reliable power generation

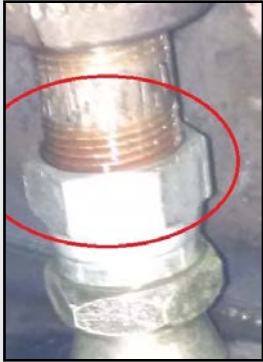
| Issue – Main Feedwater Pump Fitting Leak | Conservative Decision | Quality Issue | Human Performance |
| <ul style="list-style-type: none"> <li>– Oil leak developed internal to the high-pressure governor control block – Was not visible or detectable to the operator</li> <li>– A main feedwater pump speed reduction occurred as leak worsened – Operators manually tripped the plant to prevent a low/low steam generator level trip</li> <li>– Cause was determined to be the wrong application/type of fitting for oil line</li> <li>– Extent of condition performed – All other similar fittings inspected, with one requiring replacement</li> <li>– Determined to be a legacy issue, undiscovered during refurbishment</li> <li>– 2<sup>nd</sup> main feedwater pump had not yet been placed in service because power level did not require it</li> <li>– Had 2<sup>nd</sup> pump been in service, no transit would have occurred, no trip would have been necessary – Leak would have been repaired online</li> </ul> | Yes | Yes | No |
